Control Chief Radio Modems, used on PTS, Trac-a-Rac, and Paco Crawler

Instructions for converting the Old series 2400 to new series 2410

ISSUE: Replacement radio cards fault when installed in the rack.

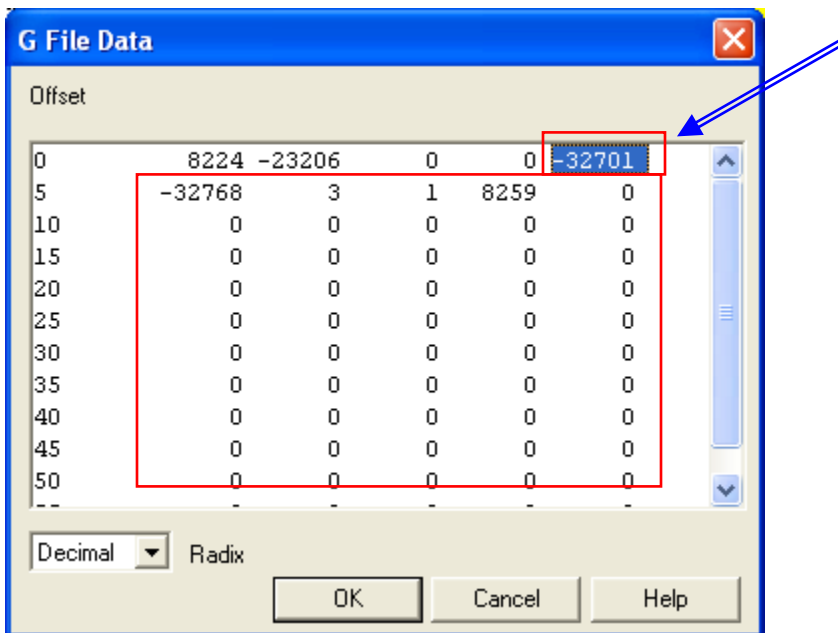
Original G File:

Due to changes made in the newest revision of the Control Chief Radio Modems, the G file must be changed in the RSLogix software. This can be done by editing the IO configuration for the slot that the radio modem is installed in. The required steps to complete this procedure are outlined in this document.

4. The values in the first two columns of row 0 MUST match the values of the G File of the other car. **Change the remaining values to 0.**
