**KNOWLEDGE BASE**Article Type: **Instructions****Control Chief Radio Modems,
used on PTS, Trac-a-Rac, and
Paco Crawler****Description:**

Control Chief Radio Modems

Instructions for converting the Old series 2400 to new series 2410

ISSUE: Replacement radio cards fault when installed in the rack.

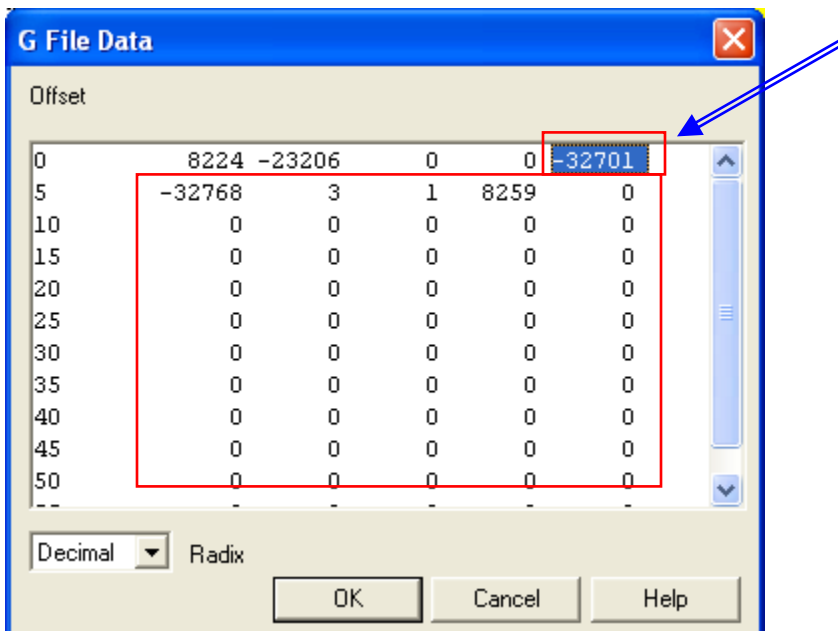
Original G File:

4. The values in the first two columns of row 0 MUST match the values of the G File of the other car. **Change the remaining values to 0.**
