**KNOWLEDGE BASE**Article Type: **Instructions****Control Chief Radio Modems,
used on PTS, Trac-a-Rac, and
Paco Crawler****Description:**

Control Chief Radio Modems

Instructions for converting the Old series 2400 to new series 2410

ISSUE: Replacement radio cards fault when installed in the rack.

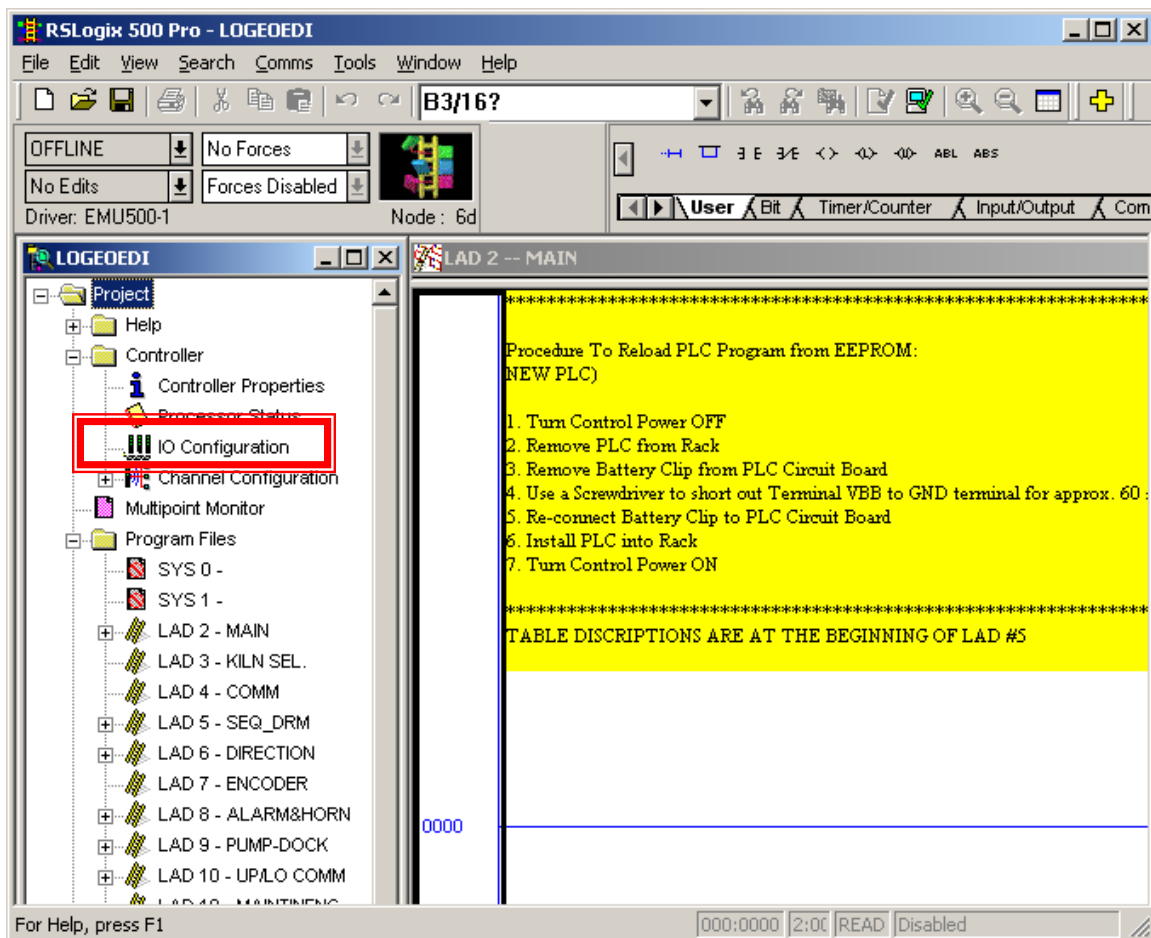
Due to changes made in the newest revision of the Control Chief Radio Modems, the G file must be changed in the RSLogix software. This can be done by editing the IO configuration for the slot that the radio modem is installed in. The required steps to complete this procedure are outlined in this document.

1. Open the plc program in RSLogix 500 in OFFLINE mode and navigate to **IO Configuration** under the Controller Folder.
